State of Maryland

Interagency Commission on School Construction

Maintenance of Maryland's Public School Buildings Fiscal Year 2025 Annual Report

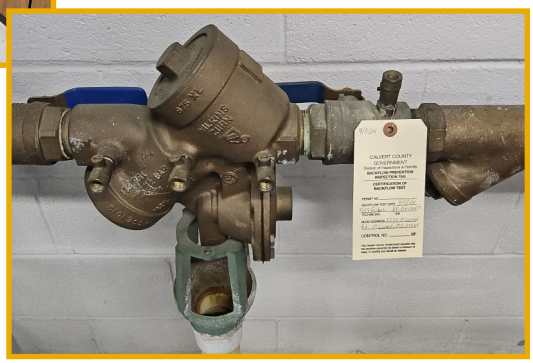
No issues or concerns were identified with the conveyances at either of the two facilities with conveyance systems. The DLLR certificates were current and on display.

The plumbing fixtures appeared to be well maintained and no leaking or corrosion were observed. All backflow preventer inspections were current.

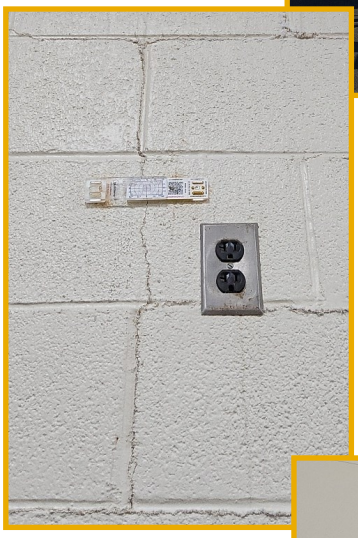
Multiple crack monitors were installed on interior walls, and some crack repairs were observed. Evidence of mortar joint repointing was observed on exterior walls at two facilities. Most wall finishes appeared well maintained.

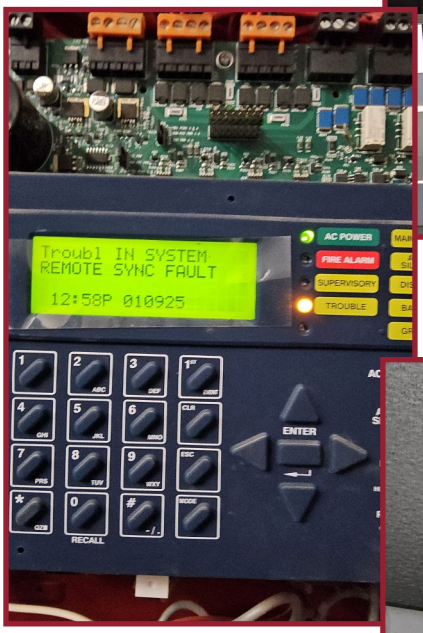
Two facilities did not have current fire alarm inspection reports, with one of those facilities also missing a current hood suppression system inspection report; the LEA did not provide a PM schedule for either facility. Another facility, which had fire alarm panel inspections identified in its PM schedule, was observed with its fire alarm system in trouble status.

Some HVAC units were non-functional at two facilities. Two other facilities were observed with black substances on an HVAC unit.

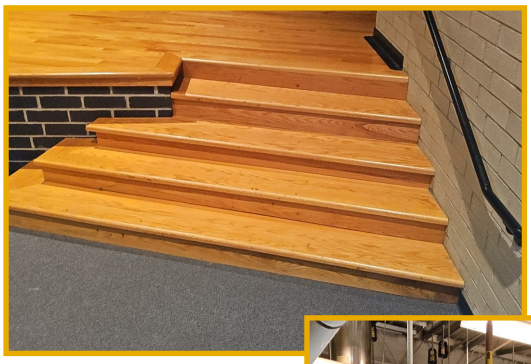
No issues or concerns were identified with the floors at four facilities, and no issues were noted with the hardwood or carpet flooring at any facility.

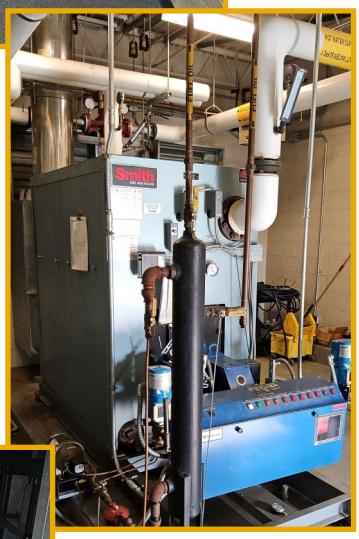
The DLLR certificates were current for all boilers, water heaters, elevators, chillers, air compressors, and heat exchangers. All backflow preventer inspection tags had current dates to verify they were in proper working order.

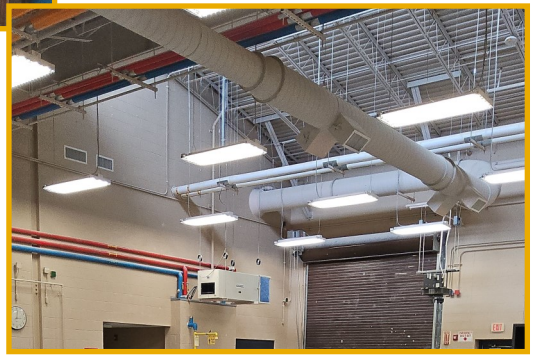
No issues or concerns were identified with the water heaters or boilers. The DLLR certificates were current for all applicable water heaters, boilers, air compressors, and pressure vessels.

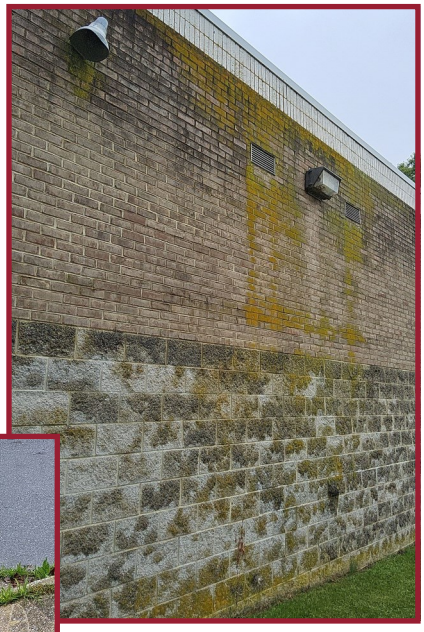
There were no PM activities for the exterior structure and finishes identified in the PM schedule for any facility. Five facilities were observed with staining and/or efflorescence on the exterior structure. Cracked and/or deteriorated expansion joints or brick mortar were noted at five facilities.

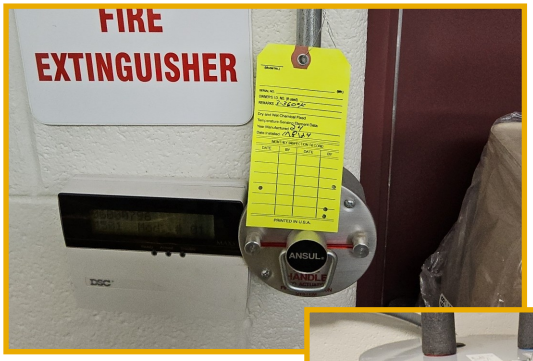
No issues or concerns were identified with the fire and safety systems at two facilities. All fire alarm system, sprinkler system, and ANSUL system inspection reports were current.

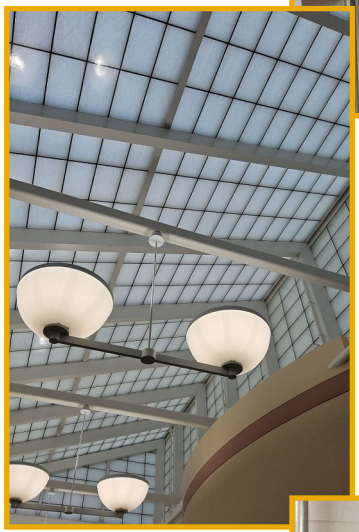
No issues or concerns were observed with the windows or skylights at four facilities. All operable windows functioned as intended. All skylights appeared to be watertight.

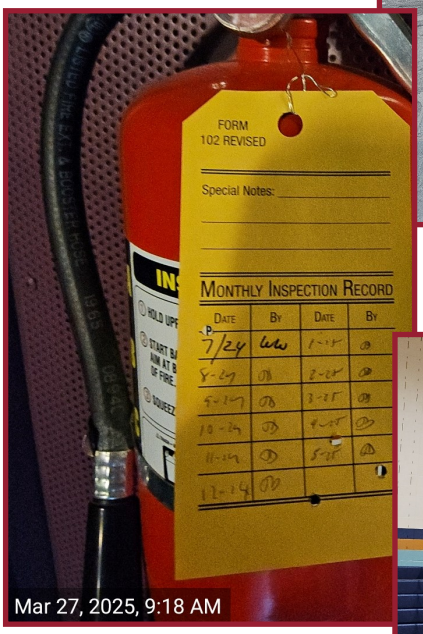
The fire extinguishers at seven facilities were observed with missing monthly inspections while the inspection tags on some other fire extinguishers were noted as being pre-dated for the following month.

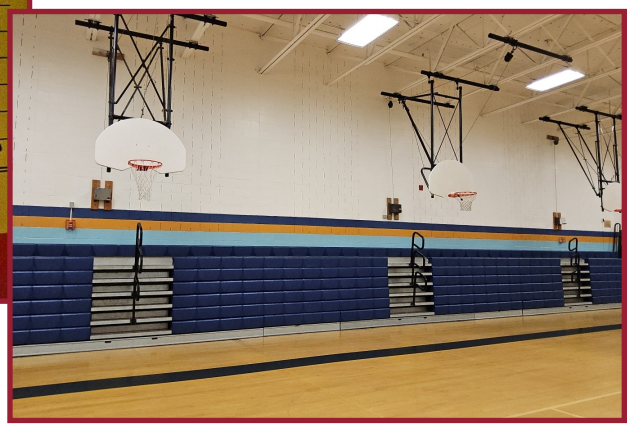
Of the four facilities with bleachers, all of the inspection reports for indoor bleachers were over a year old.

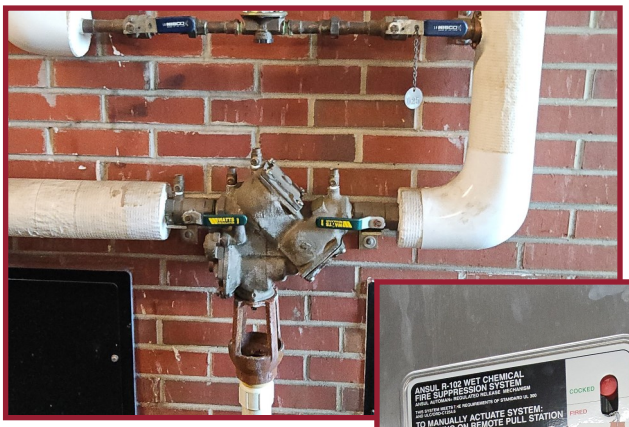
Some PM activities in the PM schedules included multiple assets instead of individual entries for each asset or asset type. Fire and safety system inspections were identified in the PM schedule at all three facilities; however, the ANSUL system inspection was expired at all three facilities.

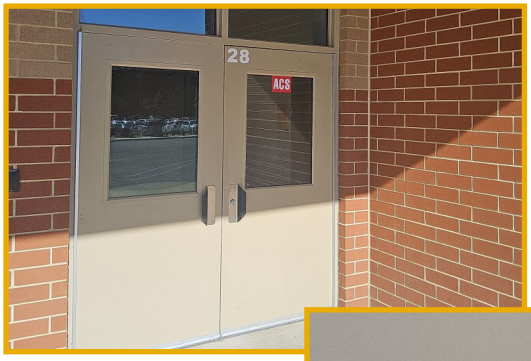
Most exterior doors appeared to function properly and were observed with numbers visible from the exterior. This best practice assists building occupants and emergency responders.

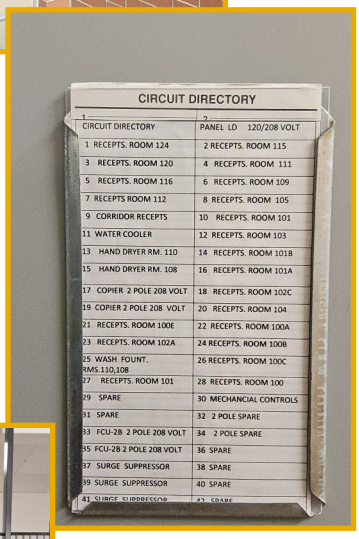
Most electrical panels were observed with detailed breaker schedules. Generators were included in the PM schedule at most facilities and most generators were noted as having no issues or concerns.

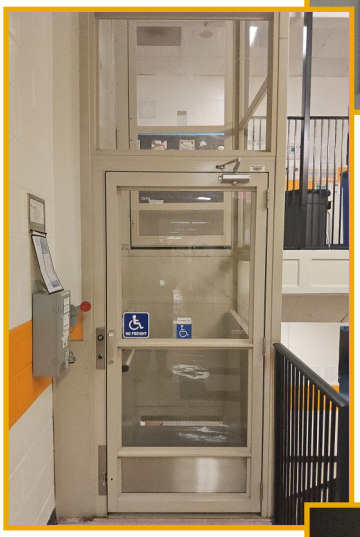
No issues or concerns were identified with the conveyances at 17 out of the 21 facilities with conveyance systems and no issues were observed with the functionality at any facility. The DLLR certificates were current for all elevators.

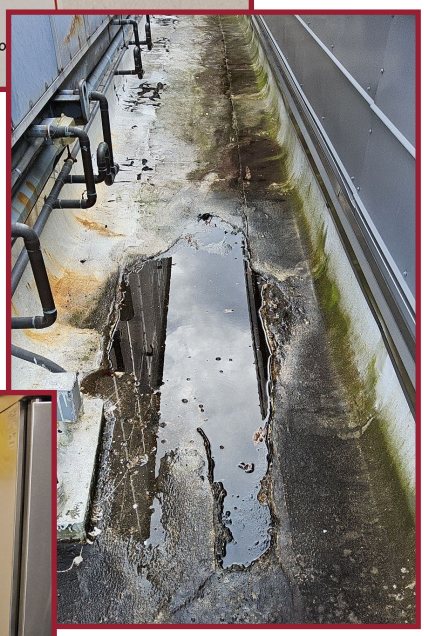
Even though current roof inspection reports were provided for all 24 assessed facilities and annual roof inspections were identified in the PM schedule at most facilities, sealants or roof membrane were observed deteriorating, peeling, and/or cracked at 18 facilities, ten facilities had blisters, and five facilities had evidence of ponding water.

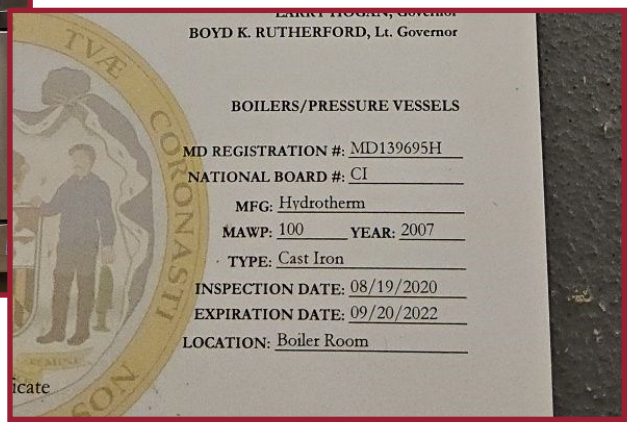
The DLLR certificates for boilers or water heaters at seven facilities were either missing or expired.

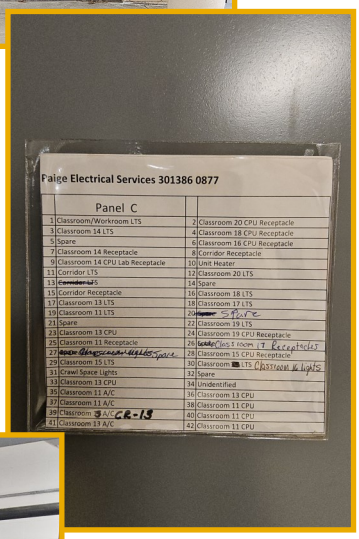
No issues or concerns were identified with the electrical distribution or service equipment at two facilities. Most electrical panels were observed with detailed breaker schedules.

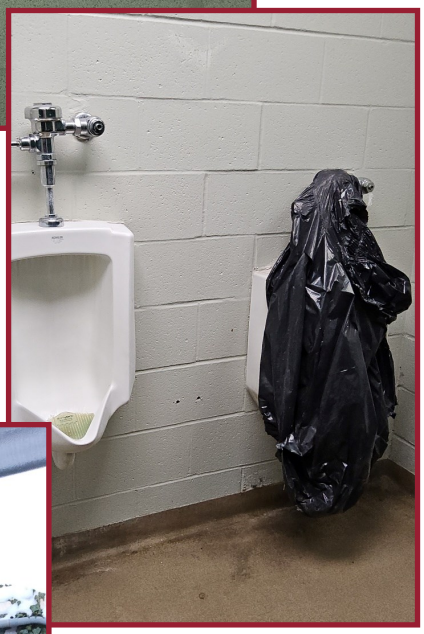
Many assets were not identified in the PM schedules for the assessed facilities, and many assets in the PM schedules did not have any PM work orders closed within the past year. Two facilities had annual plumbing audits identified in their PM schedules but no PM work orders closed within the past year; the third facility did not have any plumbing audits, assets, or restroom fixtures identified in its PM schedule. All three facilities were observed with some restroom toilets, urinals, and/or faucets damaged, leaking, or not functional.

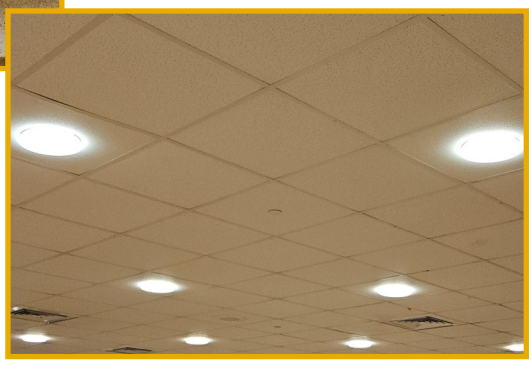
Most interior lighting fixtures appeared to be functioning properly. One facility was observed in the process of upgrading to light-emitting diodes (LEDs).

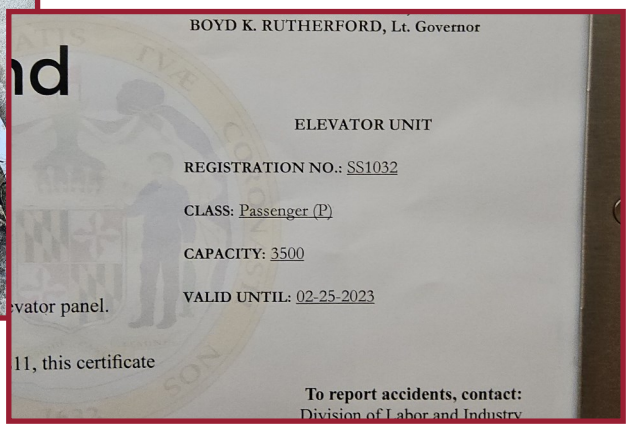
Conveyances were not identified in the PM schedules for any of the assessed facilities. The DLLR certificates were expired for conveyance systems at two facilities.

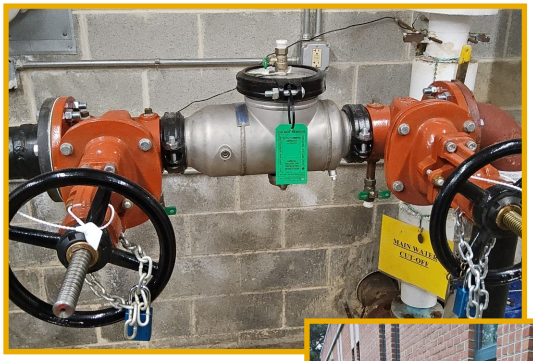
All three facilities had current backflow preventer inspection tags to verify that they were in proper working order.

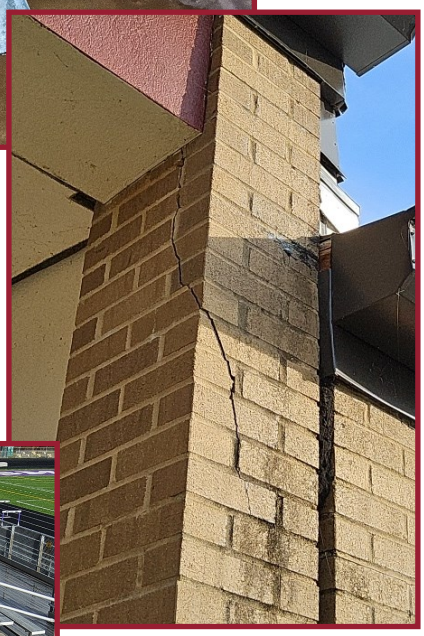
Even though exterior lighting and masonry inspections were included in the PM schedule for every assessed facility and corresponding PM work orders were identified in the closed work order history within the past year, three facilities were observed with exterior lights illuminated during the daytime, three facilities had cracks in the brick and mortar, and another facility had deteriorated brick mortar.

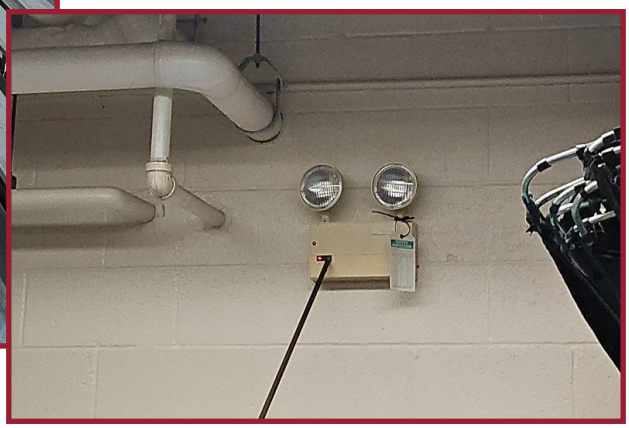
The fire alarm control panel was in trouble status at three facilities. Four facilities were observed with a non-functioning emergency light. Emergency lights were not identified in the PM schedule for any of the assessed facilities.

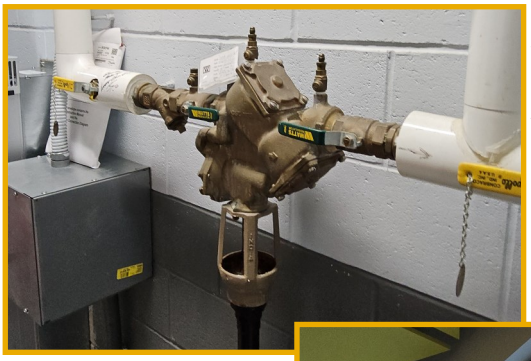
Backflow preventers were included in the PM schedule at each facility. All backflow preventers in the main building at each facility had current inspection tags.

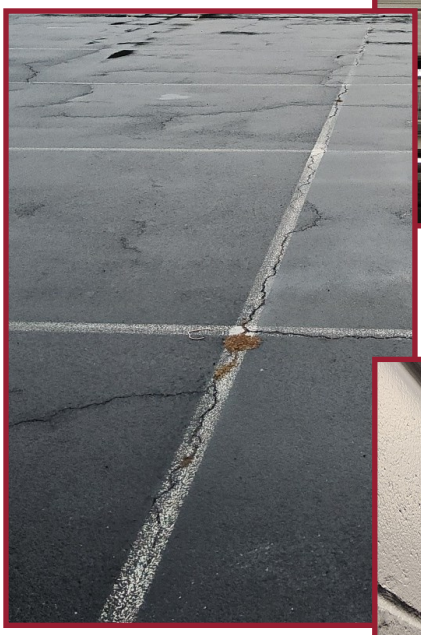
Parking lots were included in the PM schedule at all three facilities but no PM work orders had been closed within the past year at any facility. Cracks were observed in the parking lots at two facilities.

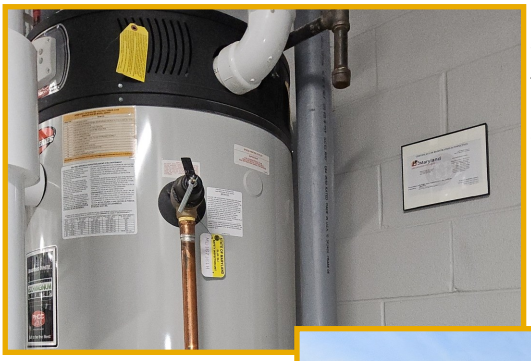
No issues or concerns were identified with the boilers or water heaters at any facility. The DLLR certificates were current and on display for all applicable boilers and water heaters.

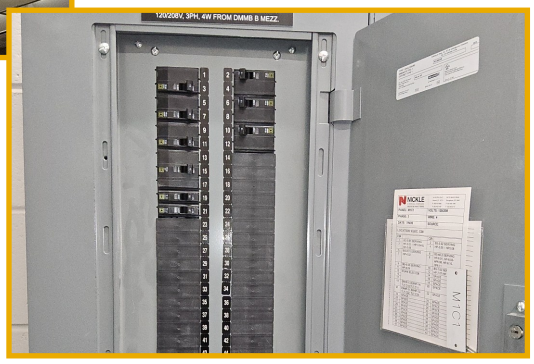
No issues or concerns were identified with the electrical distribution or service equipment at two facilities. The electrical panels were observed with detailed breaker schedules.
